NBSIR 73-166

Fire Endurance Test of an Interdwelling Double Wall Construction of Paper Honeycomb and Gypsum Board

Final Report

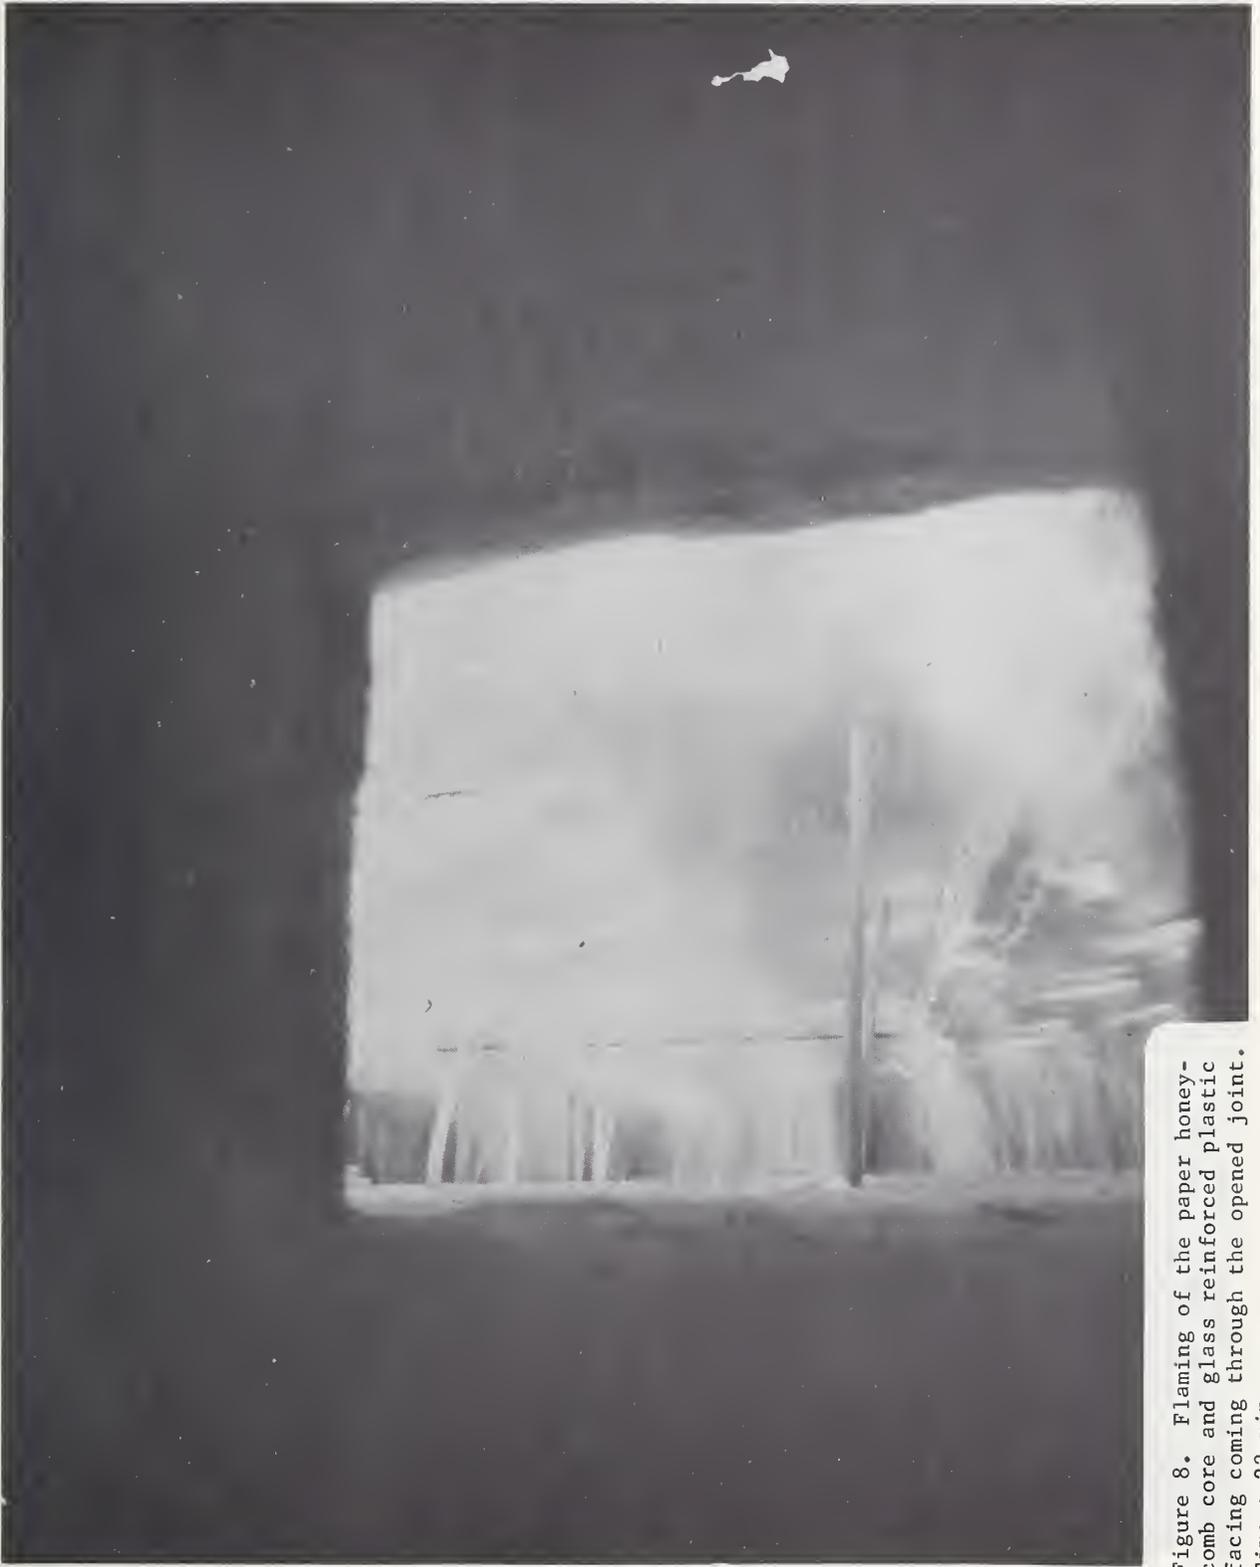
Figure 8. Flaming of the paper honey-
comb core and glass reinforced plastic
facing coming through the opened joint.
Time : 22 min.

22:00	First joint from the north end flaming inside the furnace. Figure 7 is a picture taken through the observation window, showing flames from the paper honeycomb core and glass-reinforced plastic skin coming through the opened joint.

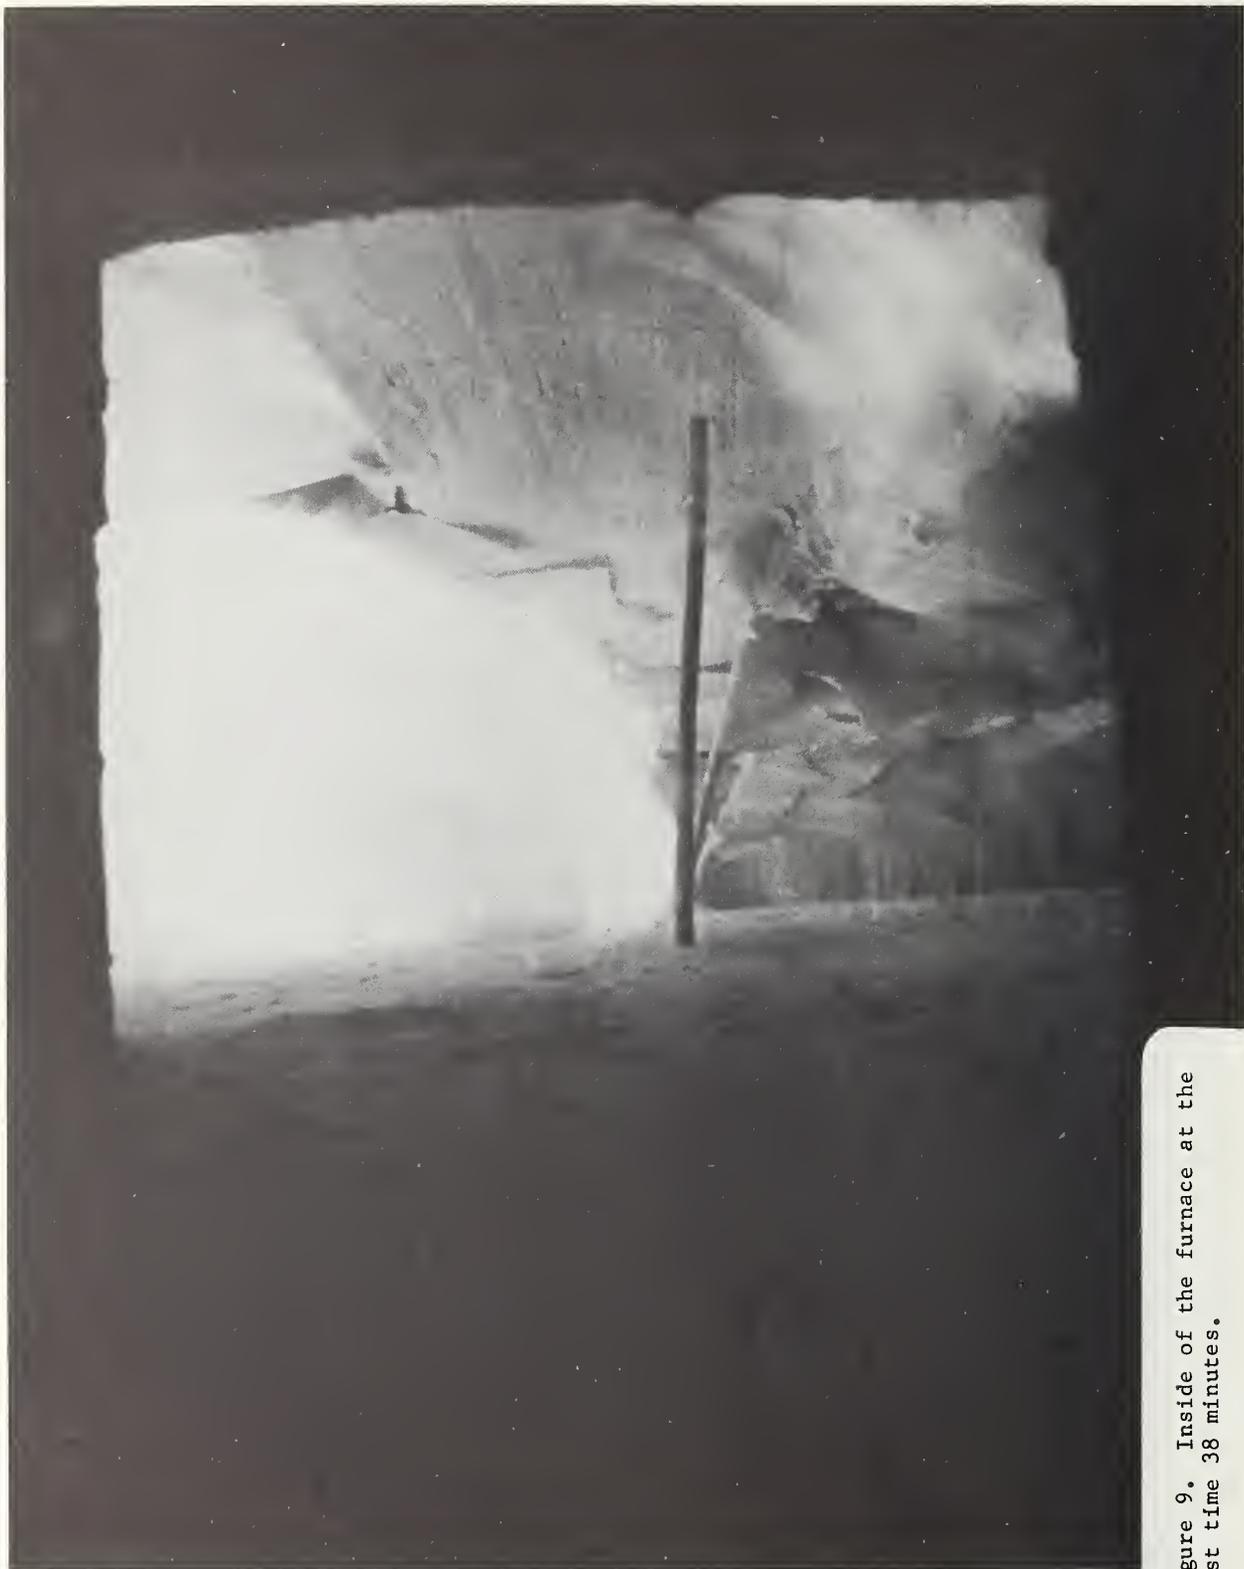
Figure 9. Inside of the furnace at the test time 38 minutes.

38:00	Collapse of 2/3 of the front face of the first wall. Figure 8 shows woven glass pieces hanging down on the ASTM furnace thermocouples and flaming from the hole in the face of the wall.

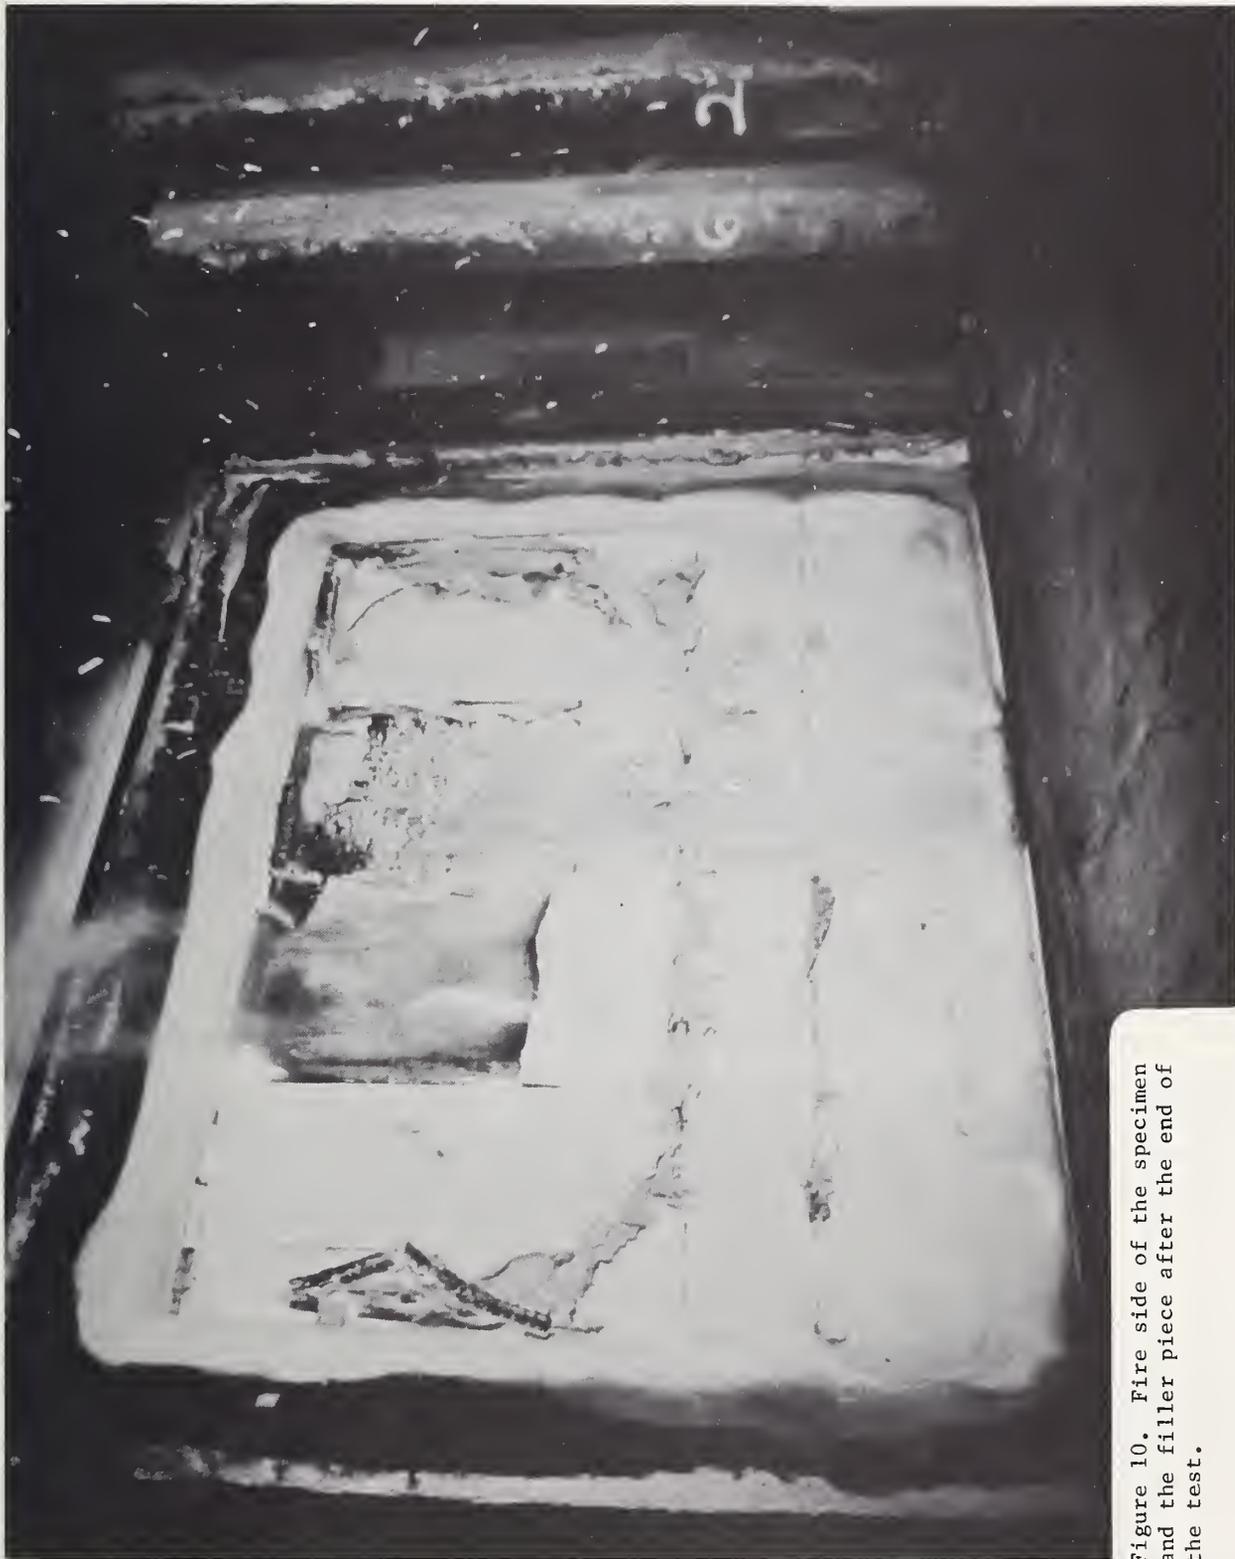
Figure 10. Fire side of the specimen and the filler piece after the end of the test.

93:40	Load Off. End of Test (Figure 9 shows the fire side of the wall assembly right after it was removed from the furnace.)
